Manhole Inspection Summary

Manhole # S21WW1037MH

Insp Date: **12/19/06 9:37 AM**

Location Address: **5106 CROSS KEYS RD** Cross Street: **HAMLET HILL RD**

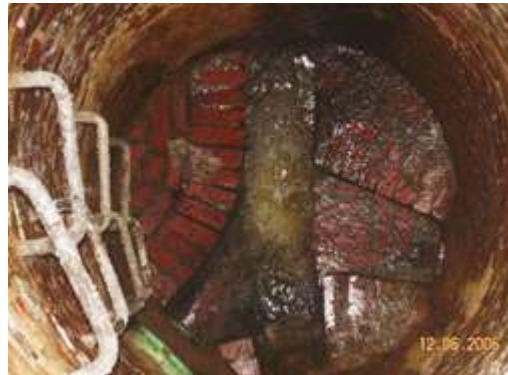
Top View

Bench ☒ Exists Material: **Brick** ☐ Parged ☒ **Debris** (not Condition related)
Condition: ☒ Sound ☐ Cracked ☐ Root Intrusion ☐ Deteriorated ☐ Leaks ☐ Debris

Bench debris.

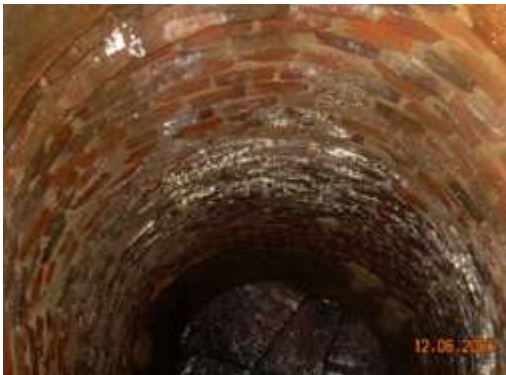
Defect

Chimney / Frame Adjustment ☒ Exists Material: **Brick** ☐ Parged Height: **3** (in.)
Condition: ☒ Sound ☐ Cracked ☐ Root Intrusion ☐ Loose Brick ☐ Deteriorated
Infiltration: ☐ None ☒ **Joint** ☐ Cracks ☒ **Mortar** ☐ Roots ☐ Wall

Corbel Material: **Brick** ☐ Parged Type: **Concentric/Eccentric**
Condition: ☒ Sound ☐ Cracked ☐ Root Intrusion ☐ Loose Brick ☐ Deteriorated
Infiltration: ☐ None ☐ Joint ☐ Cracks ☐ Mortar ☐ Roots ☒ **Wall**

Barrel Material: **Brick** ☐ Parged
Shape: **Circular** Diameter: **48** (in.) Length: (in.)
Condition: ☒ Sound ☐ Cracked ☐ Root Intrusion ☐ Loose Brick ☐ Deteriorated
Infiltration: ☐ None ☐ Joint ☐ Cracks ☐ Mortar ☐ Roots ☒ **Wall**

Frame leaks. Adjustment, Corbel and Barrel infiltration.

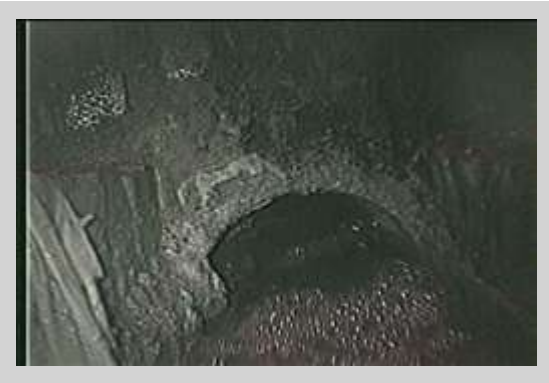
10 in. Circular Gravity Sewer Pipe Out @ 12 O'Clock

Pipe Material: **Clay** ☐ Pipe Lined

Invert Depth: **13.71** (ft.) Flow Characteristics: **Turbulent**

Infiltration: **None** Pipe Seal Cond: **Unknown**

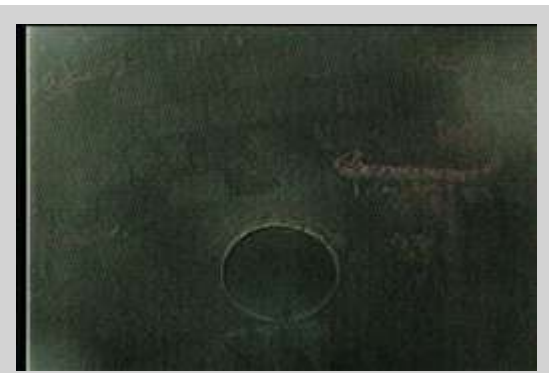
Pipe In @ 8 O'Clock

Rod and Bar (Angled)
Pipe Material: **PVC** ☐ Pipe Lined
Invert Depth: **9.25** (ft.) Flow Characteristics: **Fast**
Deposits: ☒ None ☐ Mud ☐ Sludge ☐ Debris ☐ Grease
Silt Depth: (in.) Deposits Extent:
Infiltration: **None** Pipe Seal Cond: **Unknown**

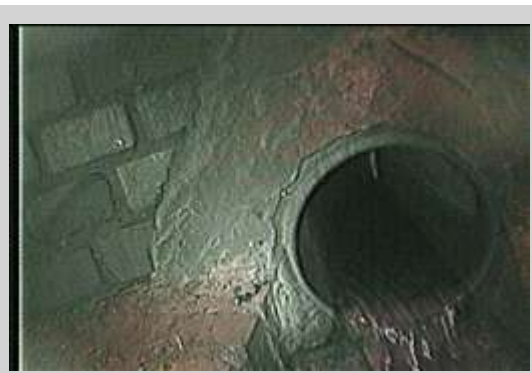
Drop In @ 8 O'Clock

Drop: **Outside** Rod and Bar
Angled: **Yes** Reading: **12.70** (ft.)
Inv Depth: **13.70** (ft.)
Drop Condition: **Open**
